*Fire resistance test in accordance with EN 1365-2:2014 of a timber floor construction made of Wolf easi-joist® system, chipboard flooring and gypsum plasterboard (15 mm Gyproc Wallboard type A) ceiling incorporating eight JCC downlights*

*Test report*

Report number Y 2271-3E-RA-001  
Date August 19, 2020  
Reference HL/TBr//Y 2271-3E-RA-001  
Representative H.H.A. Leenders, BSc.  
Author T. Brzowski, MSc.  
+31 858 228 621  
t.brzowski@peutz.nl

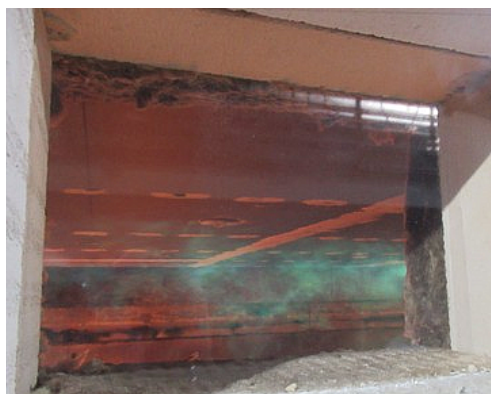
Photograph 20: During the test after 1 minute – green flames in the oven.

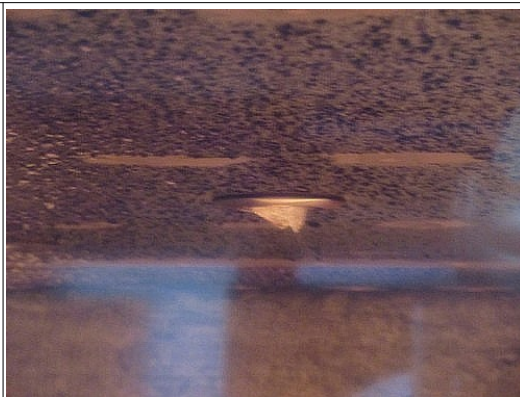
2:10	The bezel of downlight 6 starts to melt.
2:30	Dripping material from downlight 2, 5 and 8.
3:30	Paper of the gypsum boards slowly getting loose.
4:30	Dripping material from downlight 4.
5	Filler slowly getting loose, some pieces of filler falling down.
7	Downlight 4 slips slightly from the cut-out hole in the gypsum board.
7	Bigger pieces of filler falling down.
9	Downlight 5 slips slightly from the cut-out hole in the gypsum board.
13	The light bulb of downlight 7 comes loose. Lot of flames coming out.

Photograph 22: During the test after 4 minutes – dripping material from downlight 4.

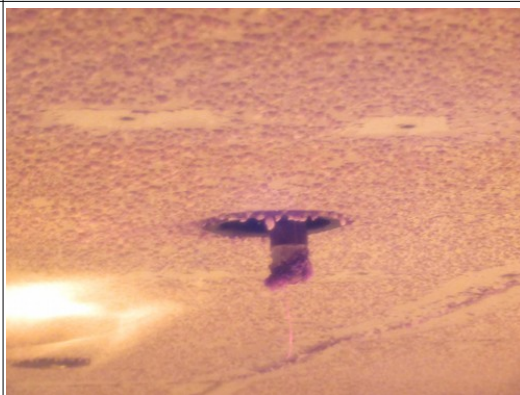
Photograph 24: During the test after 13 minutes – the light bulb of downlight 7 come loose.

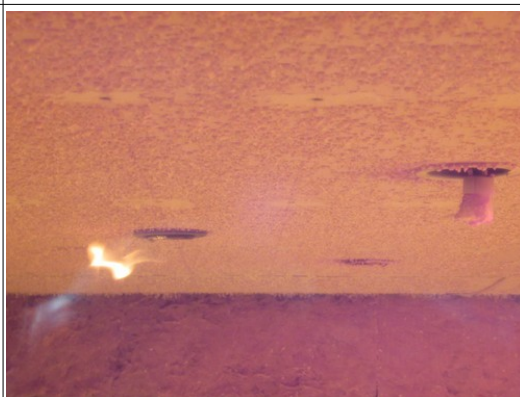
13:30	The light bulb of downlight 2 comes loose. Some flames coming out.
15	Gypsum boards start to curve between screws.
17	Piece of downlight 5 falls into the oven.
18	Flames coming out from downlight 1, 5 and 8.

Photograph 26: During the test after 18 minutes – flames coming out from downlight 8.

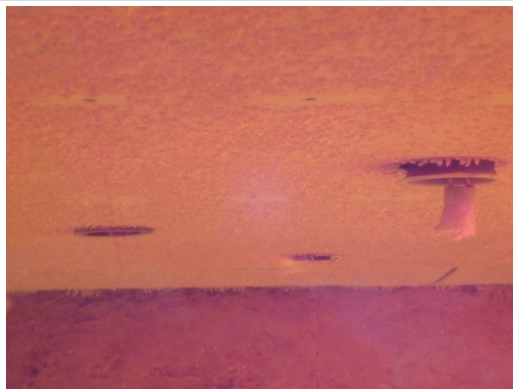
18:30	Downlight 1 falls into the oven. Lot of flames coming out from that aperture.
18:40	Piece of downlight 8 falls into the oven.
21	Joints between gypsum boards start to open.
23	Downlight 7 is sliding down from the cut-out hole in the gypsum board.
26	Flames coming out from the joints of the gypsum boards.
27	First piece of gypsum board falls into the oven.
27	Crackling sounds coming out from the burning wood.
28	Another piece of the gypsum board falls into the oven.
29	Furnace is if full of black smoke, observations from the inside are not longer possible.
31	<b>Limit for rate of deflection has been reached.</b>
32	Grey smoke coming out from the construction on both bearing sides (observation outside the furnace).
35	Amount of smoke coming out increases (observation outside the furnace).
36	Floor construction collapses. <b>Criterion Integrity (E) reached.</b>
36	End of the test.

Photograph 28: During the test after 23 minutes – downlight 7 is sliding down from the cut out hole.

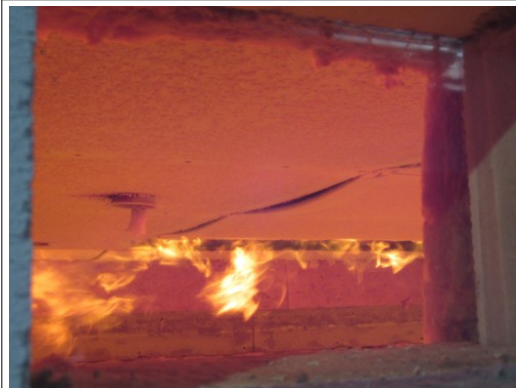
After 27 minutes of the test some of the gypsum boards fall into the furnace causing intense burning of exposed easi-joists® and chipboards. As a consequence deviations are visible on the graphs presenting the temperature inside the furnace and the overpressure in the furnace (respectively graphs number 1 and 2 and graph number 4 in Appendix 4). The pressure exceeding the upper tolerance during less than 3 minutes. In accordance with §5.2 of the EN 1363-1 pressure tolerances may be exceeded for a period of maximum 5 minutes if they are clearly identified as being associated with the sudden ignition of significant quantities of combustible materials. Therefore it will not be of influence for a possible classification of the test specimen.

Photograph 29: During the test after 27 minutes – first piece of gypsum board falls into the oven.

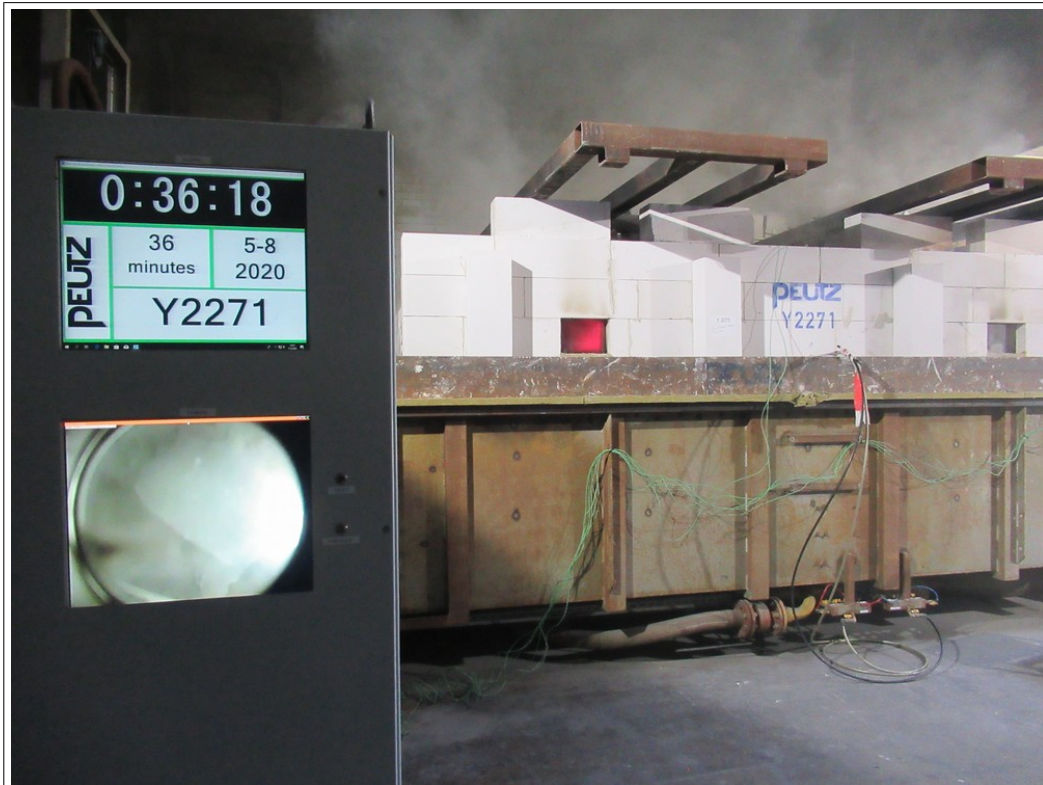
During the test, the limit for the rate of deflection was met after 31 minutes. After 36 minutes of testing (at the moment the floor collapsed) the limit for the deflection was met.

Photograph 33: During the test after 36 minutes: seconds before floor construction collapses.
