*Fire resistance test in accordance with EN 1365-2:2014 of a timber floor construction made of Wolf easi-joist® system, chipboard flooring and gypsum plasterboard (15 mm Gyproc Wallboard type A) ceiling incorporating eight JCC downlights*

*Test report*

Report number Y 2271-3E-RA-001  
Date August 19, 2020  
Reference HL/TBr//Y 2271-3E-RA-001  
Representative H.H.A. Leenders, BSc.  
Author T. Brzowski, MSc.  
+31 858 228 621  
t.brzowski@peutz.nl

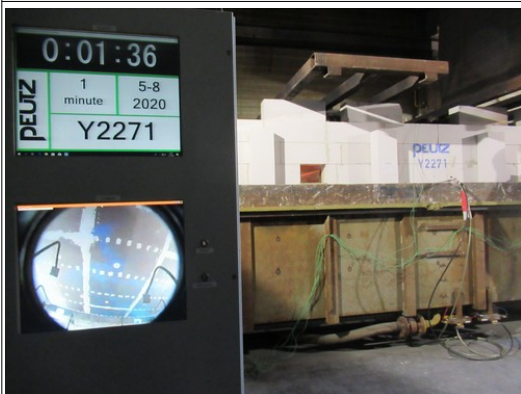
Photograph 19: During the test after 1 minute.

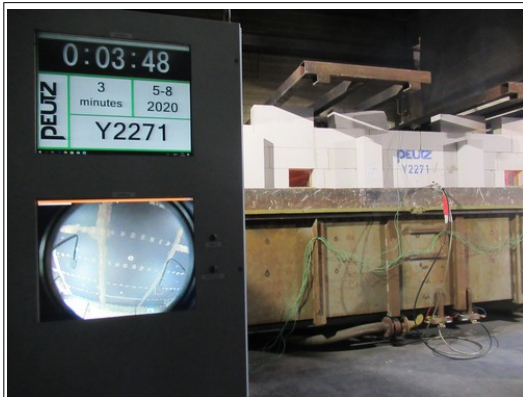
2:10	The bezel of downlight 6 starts to melt.
2:30	Dripping material from downlight 2, 5 and 8.
3:30	Paper of the gypsum boards slowly getting loose.
4:30	Dripping material from downlight 4.
5	Filler slowly getting loose, some pieces of filler falling down.
7	Downlight 4 slips slightly from the cut-out hole in the gypsum board.
7	Bigger pieces of filler falling down.
9	Downlight 5 slips slightly from the cut-out hole in the gypsum board.
13	The light bulb of downlight 7 comes loose. Lot of flames coming out.

Photograph 21: During the test after 3 minutes.

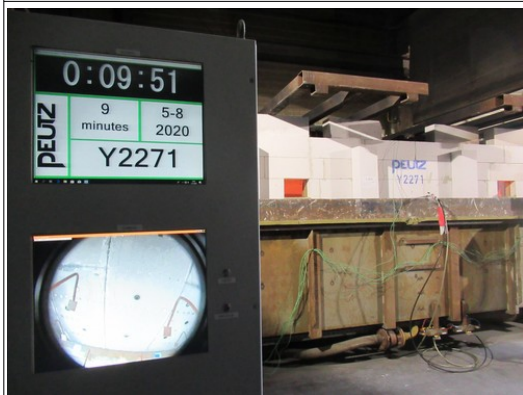
Photograph 23: During the test after 9 minutes.

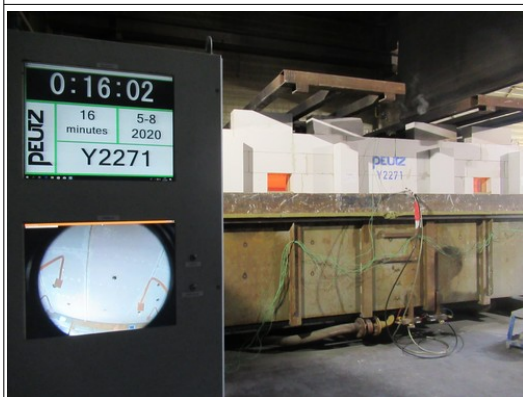
13:30	The light bulb of downlight 2 comes loose. Some flames coming out.
15	Gypsum boards start to curve between screws.
17	Piece of downlight 5 falls into the oven.
18	Flames coming out from downlight 1, 5 and 8.

Photograph 25: During the test after 16 minutes.

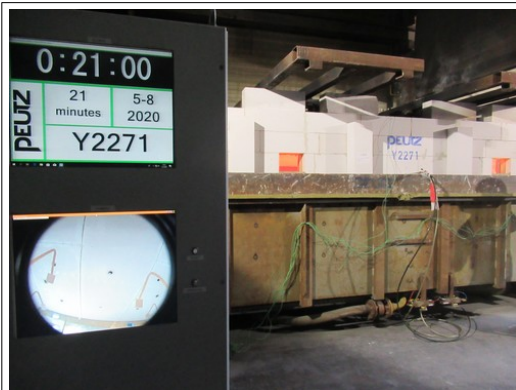
18:30	Downlight 1 falls into the oven. Lot of flames coming out from that aperture.
18:40	Piece of downlight 8 falls into the oven.
21	Joints between gypsum boards start to open.
23	Downlight 7 is sliding down from the cut-out hole in the gypsum board.
26	Flames coming out from the joints of the gypsum boards.
27	First piece of gypsum board falls into the oven.
27	Crackling sounds coming out from the burning wood.
28	Another piece of the gypsum board falls into the oven.
29	Furnace is if full of black smoke, observations from the inside are not longer possible.
31	<b>Limit for rate of deflection has been reached.</b>
32	Grey smoke coming out from the construction on both bearing sides (observation outside the furnace).
35	Amount of smoke coming out increases (observation outside the furnace).
36	Floor construction collapses. <b>Criterion Integrity (E) reached.</b>
36	End of the test.

Photograph 27: During the test after 21 minutes.

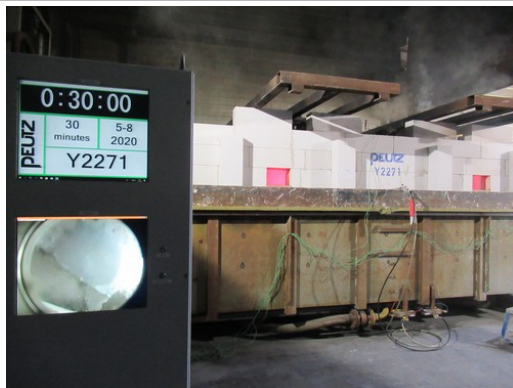
After 27 minutes of the test some of the gypsum boards fall into the furnace causing intense burning of exposed easi-joists® and chipboards. As a consequence deviations are visible on the graphs presenting the temperature inside the furnace and the overpressure in the furnace (respectively graphs number 1 and 2 and graph number 4 in Appendix 4). The pressure exceeding the upper tolerance during less than 3 minutes. In accordance with §5.2 of the EN 1363-1 pressure tolerances may be exceeded for a period of maximum 5 minutes if they are clearly identified as being associated with the sudden ignition of significant quantities of combustible materials. Therefore it will not be of influence for a possible classification of the test specimen.

Photograph 30: During the test after 30 minutes.

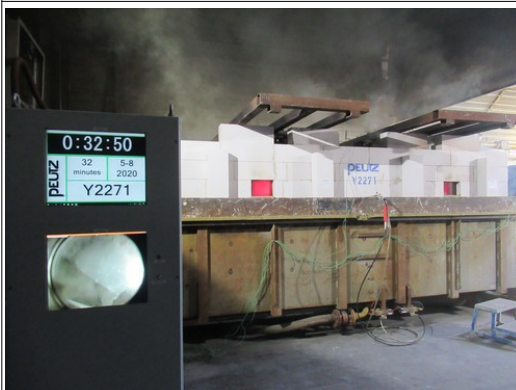
Photograph 31: During the test after 32 minutes.

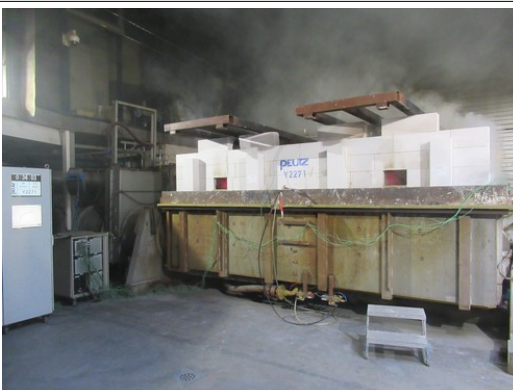
Criterion	Elapsed time	Pass / Fail
Loadbearing capacity (R)		
– limiting deflection * 1.5	36 minutes	fail (due to collapsing)
– limiting deflection	36 minutes	fail (due to collapsing)
– limiting rate of deflection	31 minutes	fail
Integrity (E)		
– sustained flaming	36 minutes	fail (due to failing R)
– cotton pad	36 minutes	fail (due to failing R)
– gap gauges	36 minutes	fail (due to failing R)
Insulation (I)		
– average temperature rise	36 minutes	fail (due to failing R)
– maximum temperature rise	36 minutes	fail (due to failing R)

Photograph 32: During the test after 36 minutes.
