Dry Cooler Repair Case Study

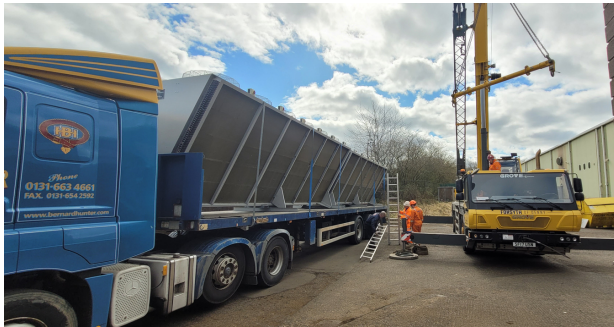
- A request was received for urgent assistance to assess & remedy leakages in a bank of dry air adiabatic coolers.
- The customer was appreciative that we were able to commit to a next-day site visit.
- Visual inspection of 3 large coolers, each 6.5m in length, 3m in width and 2.4m high revealed multiple pipework fractures in each of the 18 coil sections.
- The extensive nature of the pipework fracturing was indicative of internal liquid freezing.
- Discussions with the operations team revealed that pure water ran through the cooler tubes and because a glycol additive could not be utilized, an alternative automated frost protection control measure was in place. Examination confirmed that this had failed.
- It was strongly suspected by the visual damage to the outside of the coils that this would be replicated throughout the units and that on-site repairs were not feasible.

- The 3 large 2.5 tonne units were uplifted and transported to the Turnbull & Scott manufacturing facility in Hawick.
- The 12 fans on each unit were carefully removed to gain access to the damaged coils which were then stripped down revealing the full extent of the damage.
- It was confirmed at this stage that due to the extensive damage, all 6 heat exchanger coils in each of the 3 coolers would need to be replaced.
- The design engineers and operations team carefully measured every aspect of each CuAl coil from the fin lengths and spacings to the headers, casing components and the Cu manifolds.
- Autocad design drawings were created for the coils, pipework and manifolds and subsequently approved for manufacture.

- The manufacture and testing of 18 coils and connection manifolds was undertaken.
- The coils were re-installed and connected up with the manifolds and finally the fans were put in place and connected to in full communication with the control panels.
- The units were shipped back to the distillery for re-installation by the on-site engineering team.
-but the job was not quite done! It was realised that during the period of disconnection the on-site connecting pipework had sagged and new manifolds were urgently required to complete the installation.
- Turnbull & Scott engineers were on site within hours and measured up. Within a working day transition pieces were manufactured and delivered....now the job was finally done.
